**Report on the Results
of the
Investigation
of
Motorcycle Racing Rider Daijiro Kato's Accident
at the Japan Grand Prix -
the First Race of the 2003 Road Race World
Championship Series**

**November 2003
Daijiro Kato Accident Investigation Committee**

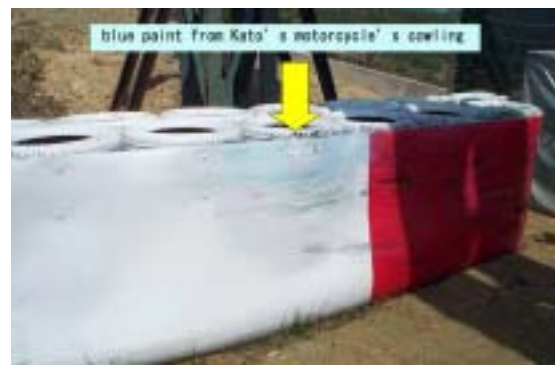
(Figure 2) Tire barrier and foam barrier (the green cone is a counterpart)

Several abrasion marks can be seen running horizontally along the outer surface of the tire barrier Kato struck, as well as blue paint from his motorcycle's cowling and other black matter. The first foam barrier bears the mark where it was struck by his motorcycle (Figures 2 and 3).

narrowest. In addition, there is a 1.2-meter gap between the two protective structures. Kato crashed into the side of the foam barrier next to the gap opening.

From the perspective of the medical forensics investigation, future measures to ensure rider safety include an examination of the layout, shape and materials of protective structures on the course. In the first place, as in ordinary accidents, racing accidents each have different causes and occur with different modalities. It would therefore be of value to improve the effectiveness of protective structures to reduce by even a small amount the shock of impact in an unforeseen collision.

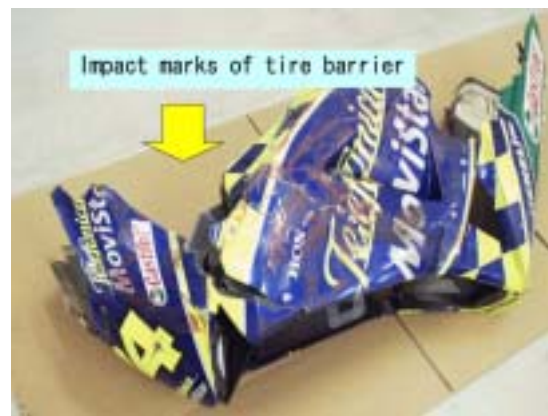
(Figure 4) Damage of the vehicle (view from above of the handle)

- (1) On the left side of the handle bars, at a height 100 cm above the ground, there is a dent and red paint from the tire barrier running towards the back of the vehicle (Figure 4).
- (2) There is a palm-sized area of red paint adhering to the left-front part of the front fender at a height 60 cm above the ground (Figure 5).
- (3) Red paint from the tire barrier can be seen adhering to various external components on the left side of the vehicle (Figure 6).
- (4) Red paint from the tire barrier can be seen adhering to the entire left-side surface of the fuel tank shell (Figure 7).
- (5) It is difficult to pinpoint when all damage found on the vehicle occurred apart from the items listed above. Nonetheless, Table 1 includes a general listing of damage caused by the impact and fall.
