**Report on the Results
of the
Investigation
of
Motorcycle Racing Rider Daijiro Kato's Accident
at the Japan Grand Prix -
the First Race of the 2003 Road Race World
Championship Series**

**November 2003
Daijiro Kato Accident Investigation Committee**

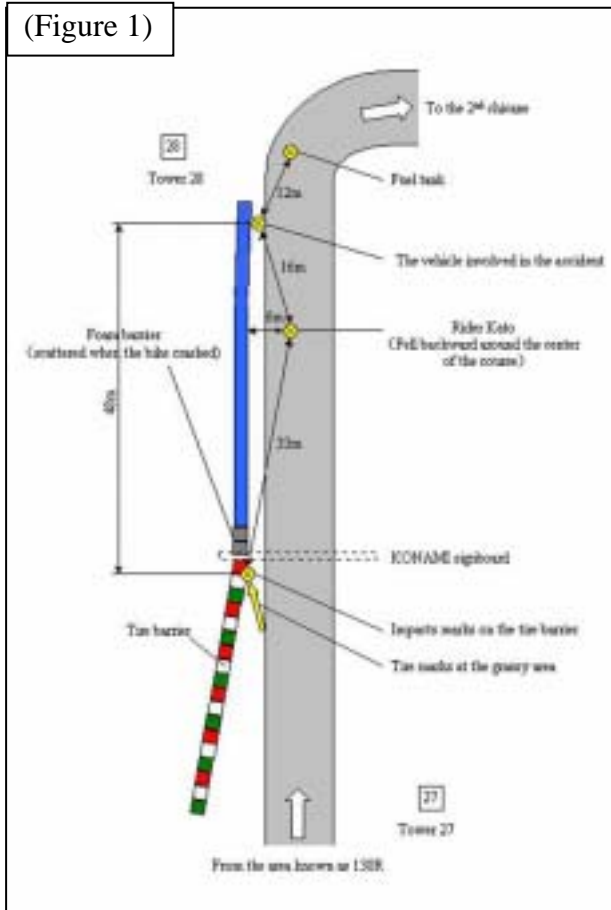
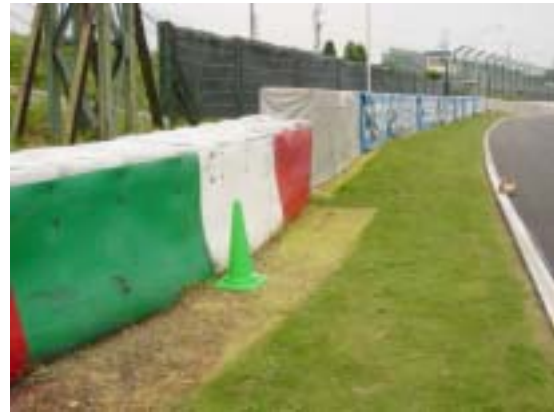
(Figure 1)

Riding in fifth place, Kato entered the area known as 130R. As he reduced speed to enter the chicane, he suddenly lost control and veered out to the left, causing the left side of his bike to violently collide with the tire barrier, after which he crashed into the adjacent foam barrier. His bike finally stopped at a point 48 meters from the point of initial impact with the tire barrier. The impact of the crash threw Kato off the bike and into the air, and his body landed face upwards on the course 33 meters from the point of impact with the tire barrier (Figure 1).

Figure 1: Rough layout of accident site
